Property Inspection Report

810 Belmont Bay Dr , Woodbridge, VA 22191

Date of Inspection: 8/14/2020

INSPECTOR: Michael L. Millspaugh License #3380000885

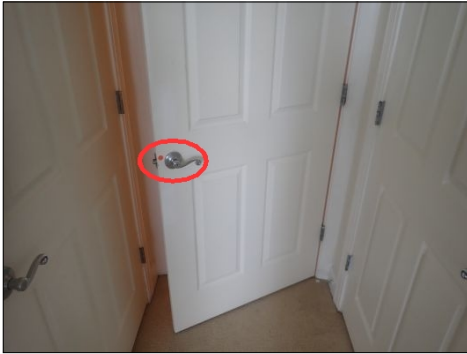
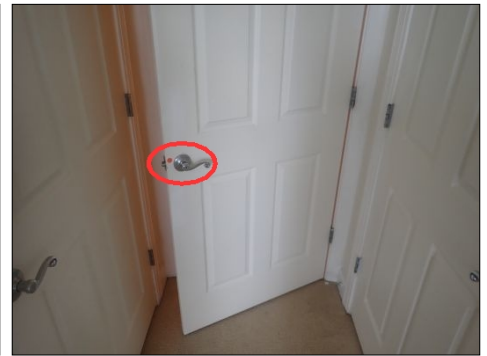
Door Not Latching

• Inspected - Repair / Replace - The bathroom door on the bedroom side did not catch when closed. The door can simply be pushed / pulled back opened. Have this door and/or catch plate adjusted by a qualified handyman.

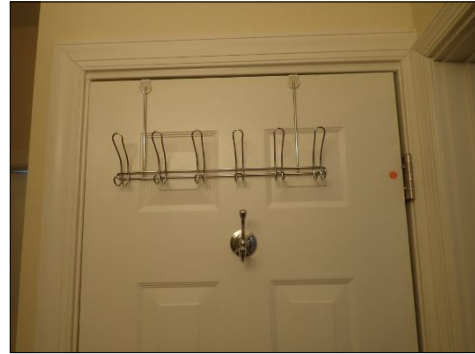
Hinge Screws

• Inspected - Repair / Replace - The utility closet door for the water heater has stripped screws. A qualified handyman is needed to repair.

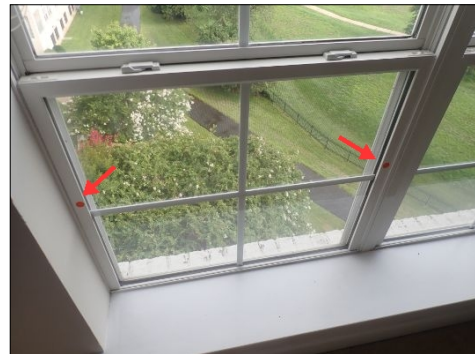
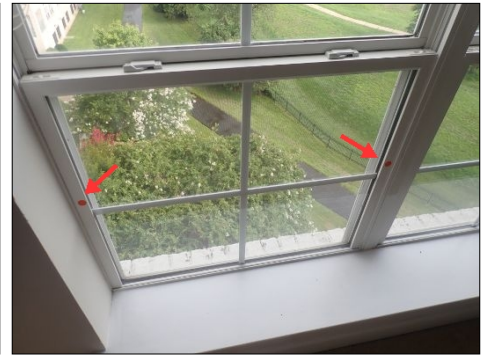
Failed Counterbalance - Bedroom

- **Inspected - Repair / Replace** - There was one window with a defective or broken counterbalance. A counterbalance is the device on each side of the window that holds the window in place when opened and released. I marked this counterbalance issue with an orange dot along the side of the window frame. Have this window repaired by a licensed window contractor. Location - Bedroom

Failed Counterbalance -
Bedroom

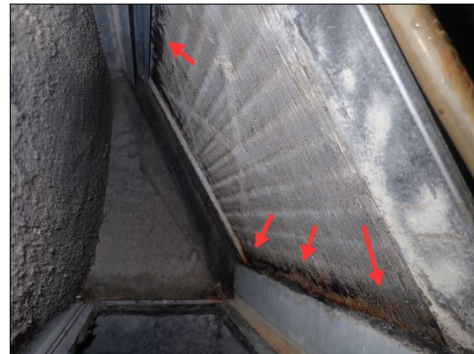
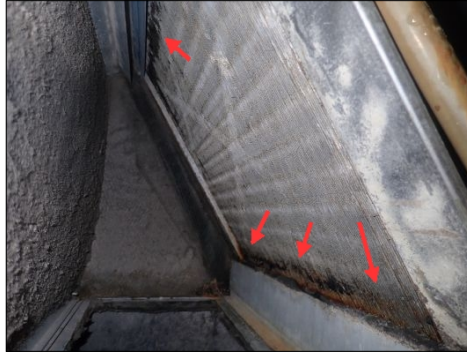
HVAC - Dirty Coils

- Inspected - Repair / Replace - The units indoor section has dirty coil fins that should be professionally cleaned to provide a more efficient cooling and heating system. Have a licensed HVAC contractor service this system and clean these coil fins. Any other recommendations made by the HVAC contractor regarding cleaning, maintenance or operation should be completed with receipts provided for your records.

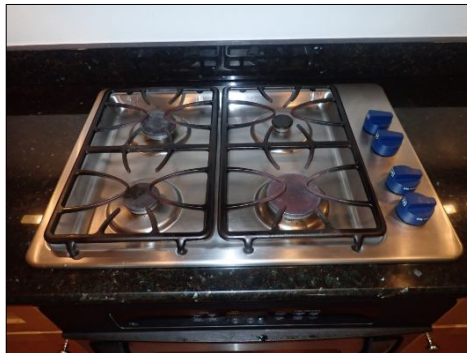
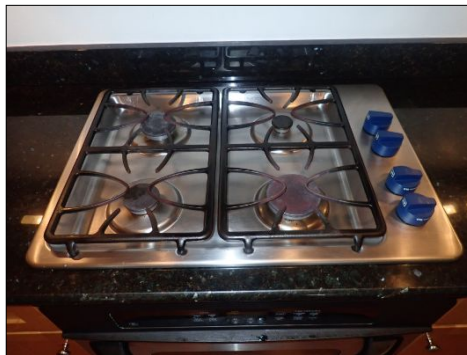
Gas Range - Loose

- Inspected - Repair / Replace - The gas range is not secured. Have a qualified appliance contractor properly secure the range to the counter top.

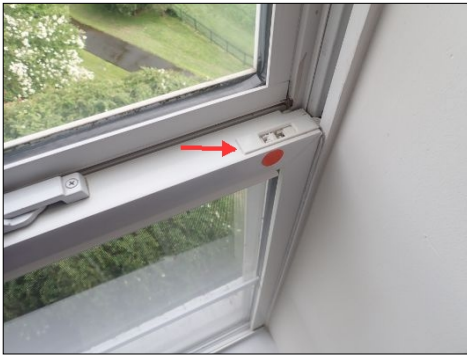
- **Maintenance Item** - There was one broken tilt release mechanism in the bedroom for the right window. These are relatively easy to replace and not expensive.

Window Tilt Release

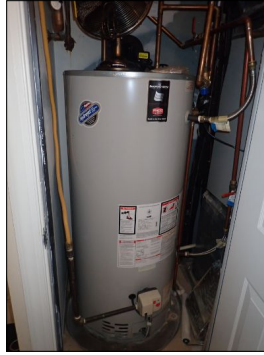
• Budget for Replacement - This water heater is only almost 7 years old. I found the water heaters temperature turned to VERY HOT , meaning it has been running at a high temperature for most likely a prolonged period of time. The average life span on a water heater is 10-12 years. One cannot determine when a water heater will fail if no evidence is found on the outside of the unit. The unit functions as intended now, however I recommend you begin budgeting for a replacement (\$2400-\$2600 installed) I just try to ensure my clients are prepared for when things do fail.

Gas Water Heater

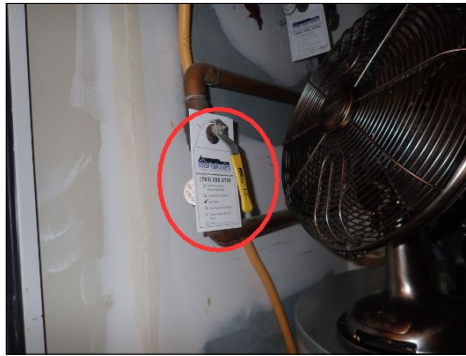
- Inspected - Clearly marked
- The main water shut off is located in the utility closet to the left of the water heater. I tested the valve and it functions. I placed a Cover Your Assets Home Inspection tag on the valve.

Main Water Valve

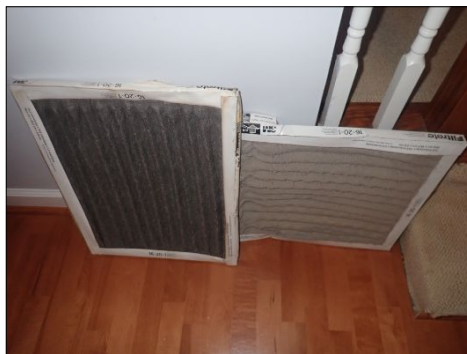
- Inspected
- The system was found with a filter in the return duct. This filter was absolutely filthy. There was also a filter in the bottom of the HVAC cabinet. This filter was dirty. The unit is designed to have one filter, and one filter only. I removed both dirty filters and installed a clean filter in the filter slot located inside the HVAC cabinet.

HVAC Filters

• **Maintenance Item** - I recommend checking the filters for the HVAC system when you take ownership of the home and replace if needed. Then, check them monthly and replace as needed. Dirty filters are the #1 cause of HVAC system failures.

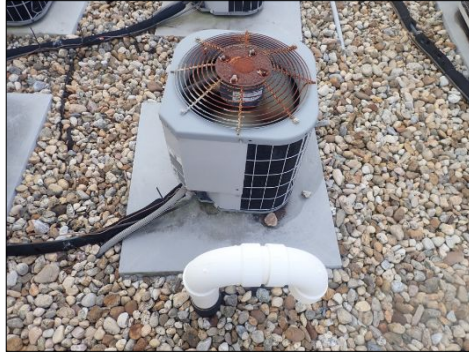
- Budget for Replacement - It should be noted that this unit is 17 years old. I recommend you begin to budget for replacement so you are prepared financially when the time comes. Estimated Cost - \$2,500 - \$3,000

A/C Unit
