# Property Inspection Report

1234 Not-A-Real-Street, Gainesville, VA 20155

Date of Inspection: 1/10/2022

INSPECTOR: Michael L. Millspaugh License #3380000885

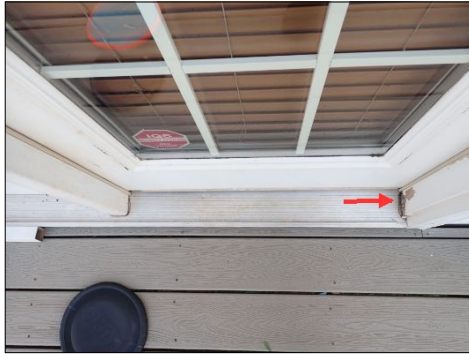
Page 13 Item: 1	WALL SIDING, FLASHING, AND TRIM	<ul style="list-style-type: none"><li>• Inspected - Repair / Replace - The door leading from the home to the deck has weathered wood trim on the outside. If left as is, this area could rot. Have a qualified contractor repair or replace as needed.</li><li>• Inspected - Repair / Replace - By the basement walk out the door, there is rotted wood trim. Have a qualified contractor replace and paint to match.</li></ul>
-----------------	---------------------------------	---

Weathered Trim

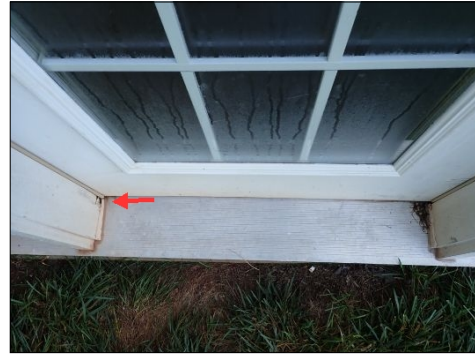
Rotted / Damaged Trim

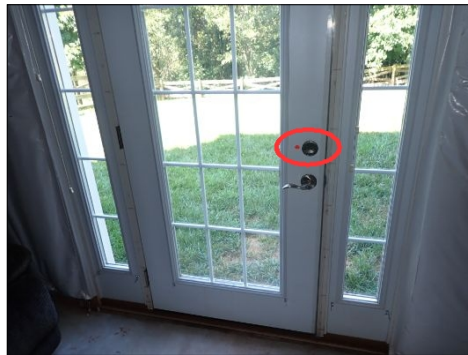
Page 13 Item: 2	DOORS (Exterior)	<ul style="list-style-type: none"><li>• Inspected - Repair / Replace - The dead bolt on the walk out door would not actuate as the bolt and catch were not aligned. Have this door / catch plate adjusted by a qualified handyman.</li></ul>
-----------------	------------------	--

Dead Bolt

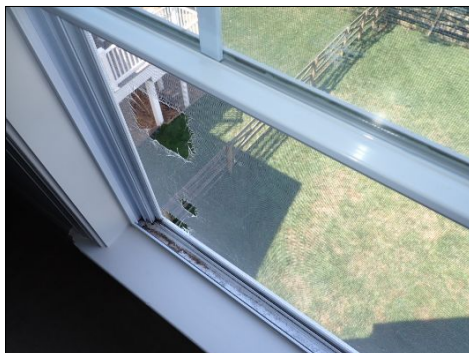
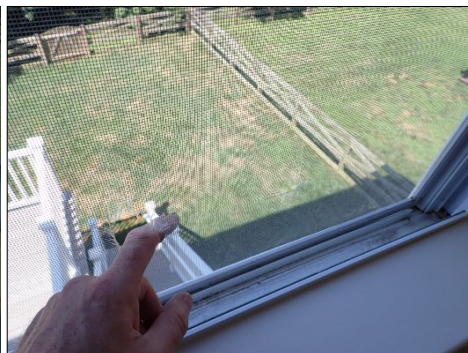
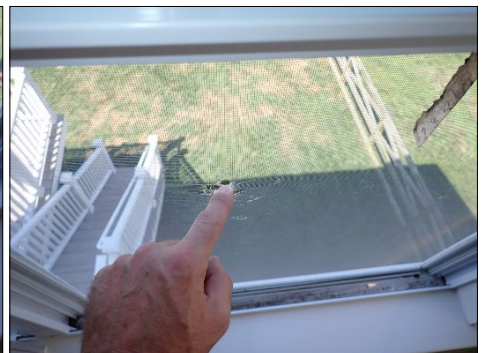
Page 14 Item: 3	WINDOWS	<ul style="list-style-type: none"><li>• Inspected - Repair / Replace - Some window screens are damaged. Below is a sampling of the screens, there were others also. Have all windows checked and have each screen repaired or replaced by a qualified contractor.</li></ul>
-----------------	---------	---

Damaged Screens

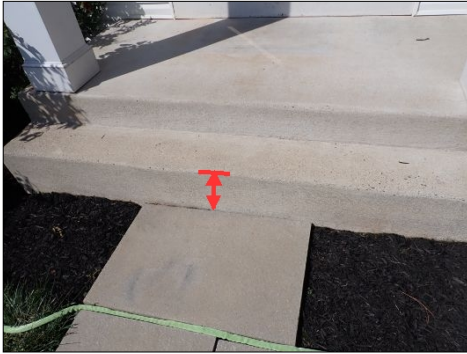
<p>Page 14 Item: 4</p>	<p>DECKS, BALCONIES, STOOPS, STEPS, AREAWAYS, PORCHES, PATIO/ COVER AND APPLICABLE RAILINGS</p>	<ul style="list-style-type: none"> <li>• Inspected - Safety Item - The riser height from the walkway to the first step on the front of the home is excessive. This creates a trip hazard. The front concrete steps appear fine, it does appear that the walkway has settled though. This is an easier fix. Have a qualified contractor remove the slabs on the walkway, regrade higher and then place the slabs. The riser height should match that of the second step on the front concrete steps.</li> </ul>
------------------------	---	--

Concrete Steps - Trip Hazard

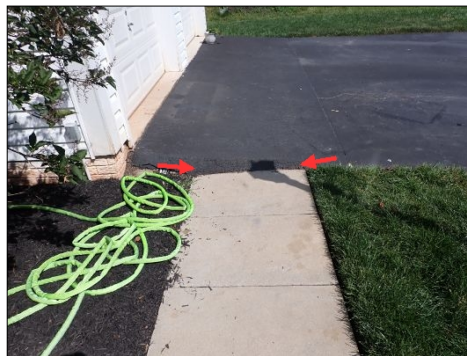
<p>Page 15 Item: 5</p>	<p>VEGETATION, GRADING, DRAINAGE, DRIVEWAYS, PATIO FLOOR, WALKWAYS AND RETAINING WALLS</p>	<ul style="list-style-type: none"> <li>• Inspected - Safety Item - Another trip hazard was noted because the driveway appears to have been altered. This should be corrected with the walkway issue mentioned in the previous section.</li> </ul>
------------------------	--	---

Walkway - Trip Hazard

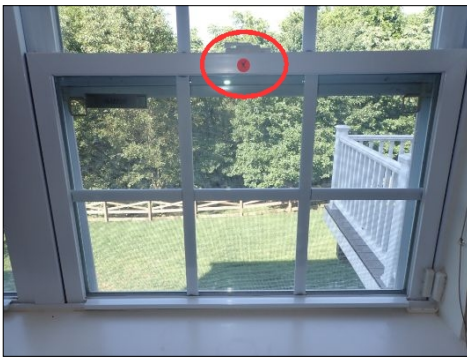
<p>Page 19 Item: 7</p>	<p>WINDOWS</p>	<ul style="list-style-type: none"> <li>• Inspected - Repair / Replace - I was unable to open the right kitchen window facing the rear of the home. This appears to be a counterbalance type issue causing the windows stick. Have this window repaired by a qualified contractor.</li> <li>• Inspected - Repair / Replace - The dining room window has a failed counterbalance. This window has been marked with an orange sticker on the right side of the window. The broken / disconnected counterbalance can be seen in the track above. Have a qualified window contractor repair this window.</li> </ul>
------------------------	----------------	--

Window - Stuck Closed

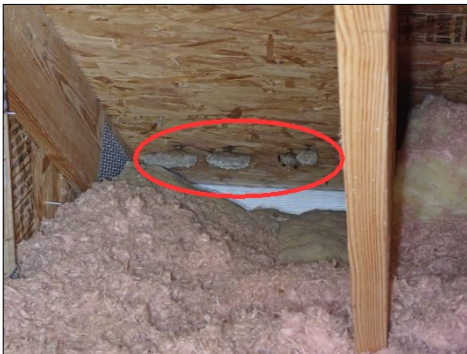
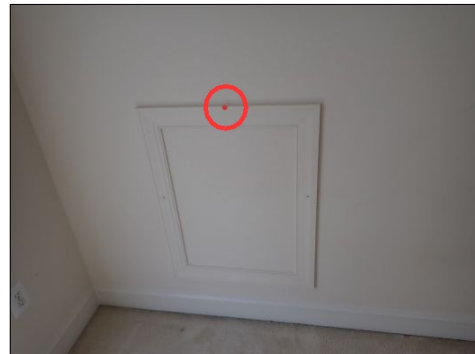
• Inspected - Repair / Replace - A group of wasp nests was visible from one of the attic access panels. I marked the access panels cover with an orange sticker. Loft area, left rear corner. A licensed pest control contractor should remove the nests and attempt to seal any entry point areas.

Wasp Nest(s)

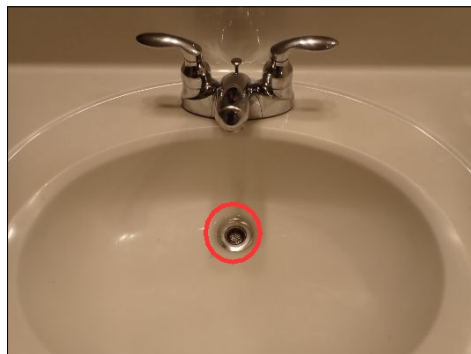
• Inspected - Repair / Replace - Multiple sinks were missing drain stops. There are times when people remove these, or they break and failed to repair them. Have a qualified plumbing contractor install functioning drain stops.

Drain Stop

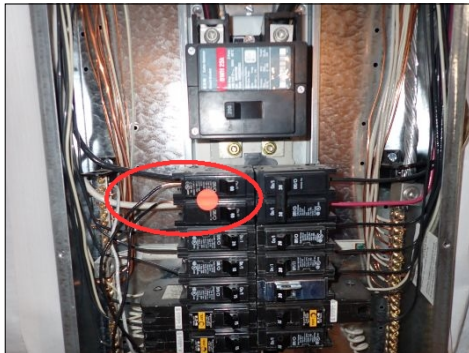
<p>Page 25 Item: 3</p>	<p><b>BRANCH CIRCUIT CONDUCTORS, OVERCURRENT DEVICES</b></p>	<ul style="list-style-type: none"> <li>• Inspected - Repair / Replace - The circuit breakers for the HVAC system are 60 Amps. There are two individual 60 amp breakers providing power to the same piece of equipment. These should be replaced with a single double pole circuit breaker by a licensed electrician.</li> </ul> <p>NOTE - While replacing the circuit breakers, electrician should correct the excessive exposed copper conductor on the surge protector.</p>
------------------------	--	---

Circuit Breaker

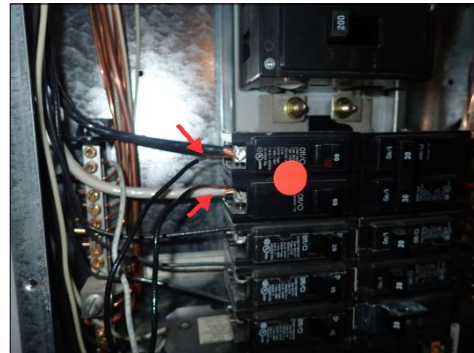
Surge Protector Wiring

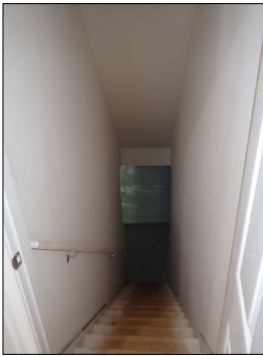
<p>Page 25 Item: 4</p>	<p><b>CONNECTED DEVICES AND FIXTURES</b></p>	<ul style="list-style-type: none"> <li>• Inspected - Repair / Replace - The 3 way switches in the stairway to the basement are not wired correctly. When one switch is off, the other should be able to turn the light on and back and forth forever. In this case, when one switch is turned off, the other ceases to function. Have these switches correctly wired by a qualified electrical contractor.</li> <li>• Inspected - Safety Item - The outlet in the basement to the right of the HVAC system needs a cover. Easy Fix.</li> <li>• Inspected - Safety Issue - There are outlets in the home that have the front plastic outlets face that is breaking off of the internal workings of the outlet. I have marked these outlets with an orange sticker with an X on it. These outlets should not be used until corrected. Have these outlets replaced by a qualified electrical contractor.</li> </ul>

3 Way Switch Wiring

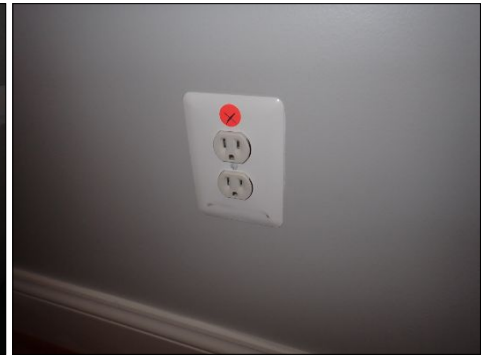
Cracked Outlet - Dining

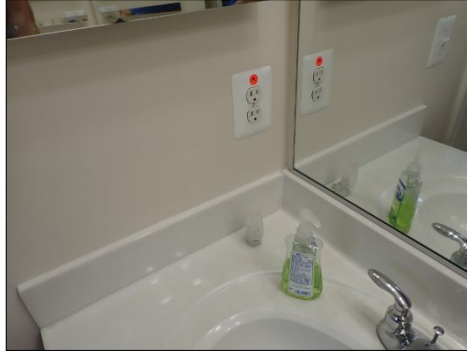
Cracked Outlet - Bathroom

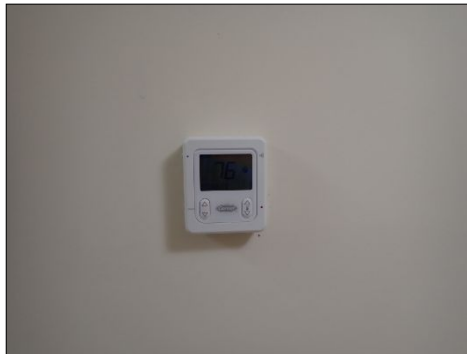
• Inspected - Repair / Replace - The thermostat on the loft level was disabled. You have the ability to have a zoned system for the upper-level HVAC. Have a qualified HVAC contractor correct.

Disabled Thermostat

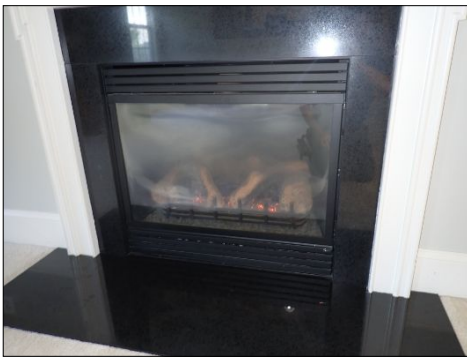
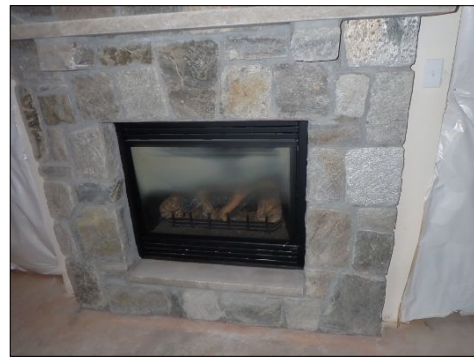
• Inspected - Repair / Replace - The gas fireplaces have glass screens that are dirty / stained. Have the gas fireplaces serviced and cleaned by a licensed contractor.

Gas Fireplace #1

Gas Fireplace #2

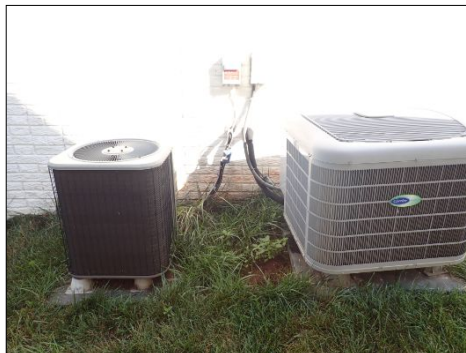
• Inspected - Repair / Replace - The unit does not appear to be operating efficiently.

**A/C** Temperature at time of inspection - 59-60 degrees.  
 The outside temperature was - 85 degrees  
 The inside temperature of the home was - 75 degrees  
 Delta Temp - ~15 degrees

Compared to the upper level HVAC system, this unit appears to be struggling under the same operating conditions. I recommend you have a licensed HVAC contractor service this unit and make any necessary repairs. Any recommendations made by the technician concerning maintenance and upkeep should be completed with receipts provided for your records.

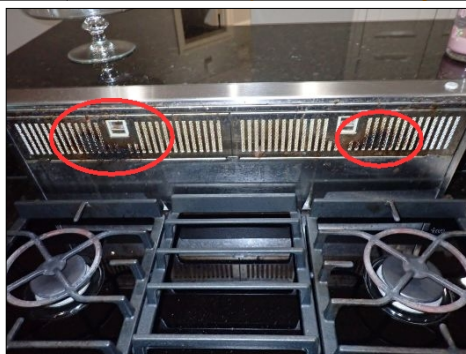
• Inspected - Repair / Replace - The filters for the exhaust fan are greasy and also have burn marks on them. These filters should be replaced if they cannot be properly cleaned.

Exhaust Fan

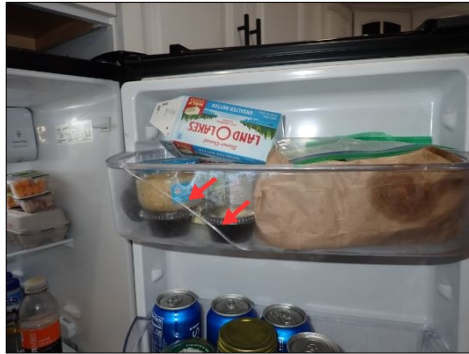
• Inspected - Repair / Replace - The plastic shelf on the door of the refrigerator is cracked.

Refrigerator - Door Shelf

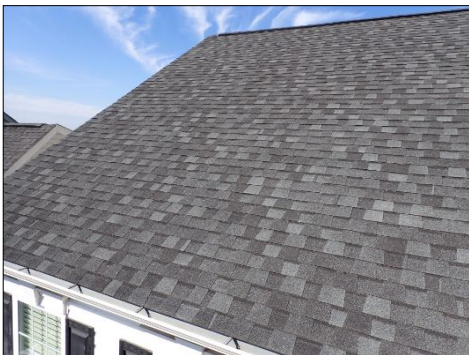
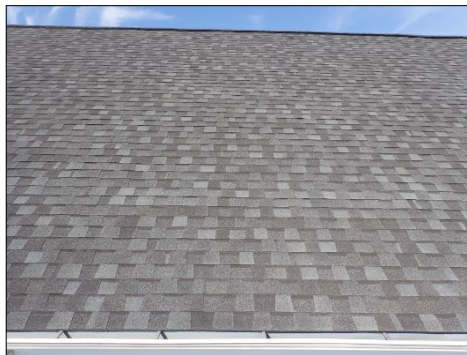
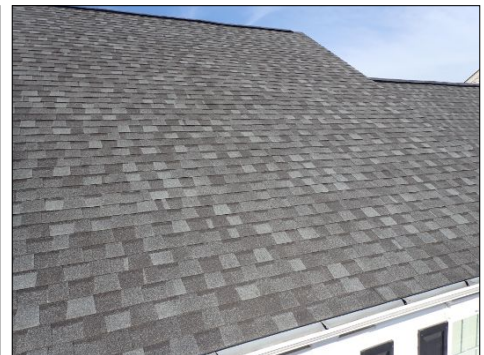
Front Shingles

- Inspected
- The home was built in 2009 and the roof covering is original. This places the roof at 13 years of age at the time of inspection. The roof appears in good condition for its age and the shingles don't exhibit any particular signs of early failure. I would estimate the shingles should be able to reach their full maturity given periodic inspections by a qualified roofing contractor as the shingles age. In the attic I found good air flow, and found no signs of any leaks from the roof sheathing. This appears to be a 20-25 year type shingle with years of life left on it.

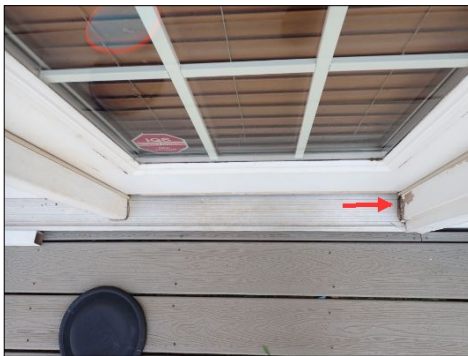
Weathered Trim

- Inspected - Repair / Replace - The door leading from the home to the deck has weathered wood trim on the outside. If left as is, this area could rot. Have a qualified contractor repair or replace as needed.
- Inspected - Repair / Replace - By the basement walk out the door, there is rotted wood trim. Have a qualified contractor replace and paint to match.

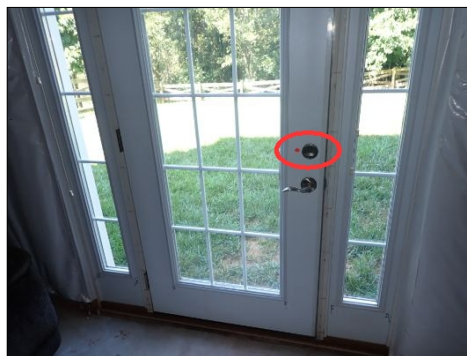
Dead Bolt

- Inspected - Repair / Replace - The dead bolt on the walk out door would not actuate as the bolt and catch were not aligned. Have this door / catch plate adjusted by a qualified handyman.

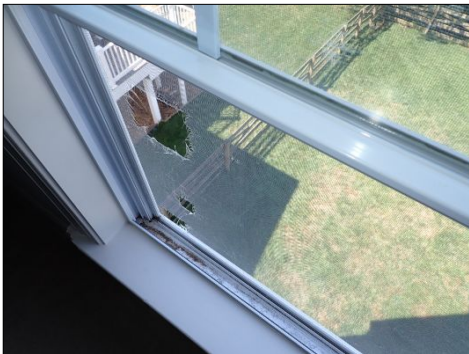
Damaged Screens

- Maintenance Item - I recommend to my clients to check and caulk the exterior windows annually. Left unchecked they could allow moisture and air to enter the home.
- Inspected - Repair / Replace - Some window screens are damaged. Below is a sampling of the screens, there were others also. Have all windows checked and have each screen repaired or replaced by a qualified contractor.

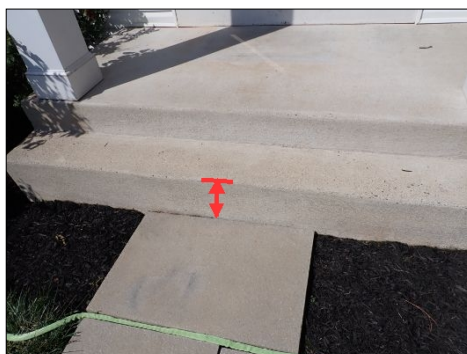
- The deck was constructed in 2011. Permit finalized.
- Inspected - Safety Item - The riser height from the walkway to the first step on the front of the home is excessive. This creates a trip hazard. The front concrete steps appear fine, it does appear that the walkway has settled though. This is an easier fix. Have a qualified contractor remove the slabs on the walkway, regrade higher and then place the slabs. The riser height should match that of the second step on the front concrete steps.

Concrete Steps - Trip Hazard

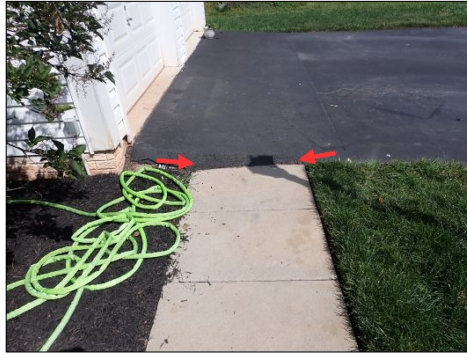
- Inspected - Safety Item - Another trip hazard was noted because the driveway appears to have been altered. This should be corrected with the walkway issue mentioned in the previous section.

Walkway - Trip Hazard

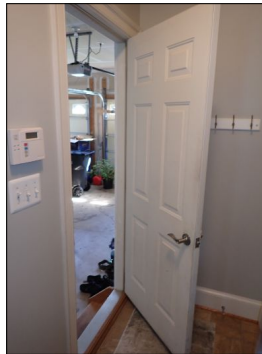
Damaged Garage Door Seal

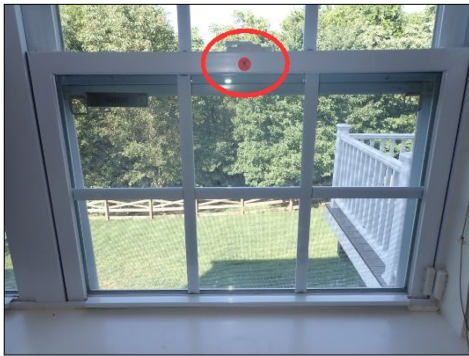
Window - Stuck Closed

- Inspected - Repair / Replace - I was unable to open the right kitchen window facing the rear of the home. This appears to be a counterbalance type issue causing the windows stick. Have this window repaired by a qualified contractor.
- Inspected - Repair / Replace - The dining room window has a failed counterbalance. This window has been marked with an orange sticker on the right side of the window. The broken / disconnected counterbalance can be seen in the track above. Have a qualified window contractor repair this window.

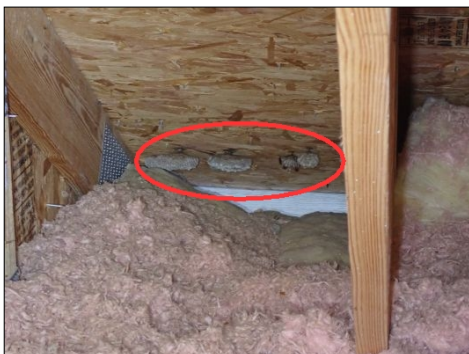
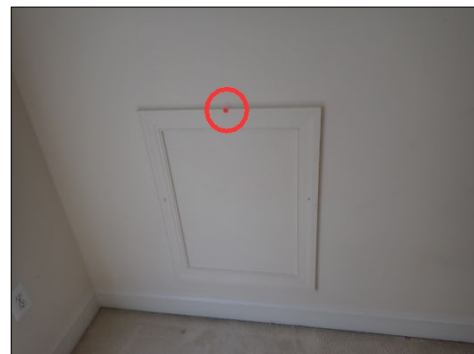
Wasp Nest(s)

- Inspected - Repair / Replace - A group of wasp nests was visible from one of the attic access panels. I marked the access panels cover with an orange sticker. Loft area, left rear corner. A licensed pest control contractor should remove the nests and attempt to seal any entry point areas.

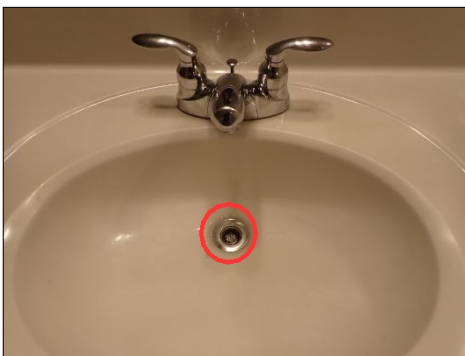
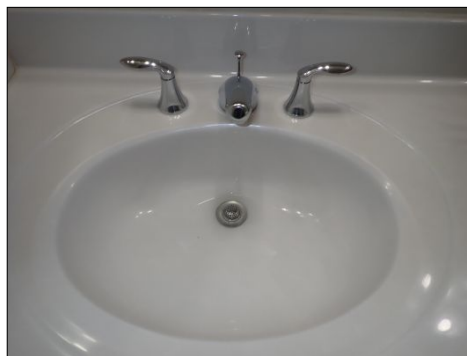
Drain Stop

- Inspected - Repair / Replace - Multiple sinks were missing drain stops. There are times when people remove these, or they break and failed to repair them. Have a qualified plumbing contractor install functioning drain stops.
- Inspected - Repair / Replace - The hot and cold were reversed for the shower in the Jack and Jill bathroom. When turning on the shower, cold water should come first, with the water warming as the handle is turned. It is this way in all other showers in the home. In the shower, hot water comes first, which is incorrect. Have a qualified plumbing contractor correct.

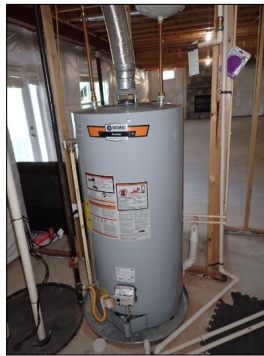
Gas Water Heater

- STATE
  - GAS
  - Serial Number - 1821110502149
  - Model Number - GS6-75-XRRS 400
  - Manufactured in - May 2018
  - Average Replacement Cost - \$1,900
  - Capacity - 75 Gallons
- Observations:
- Inspected
  - Average Life Expectancy - 10-12 Years

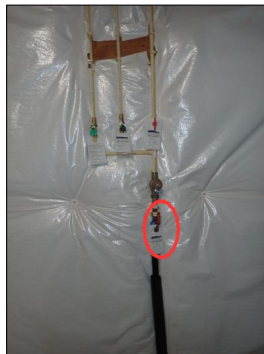
Main Water Valve

- Observations:
- Inspected - Clearly marked
  - The main water shut off is located in the basement utility area. I tested the valve and it functions. I placed a Cover Your Asserts Home Inspection tag on the valve.
  - The hose bib supply valves are located directly above the main water valve in the basement utility area. utility room <Hose Bib Supply Valve>hen the temperatures fall, You will want to winterize your hose bibs. The tag provides directions on how to winterize the valves.

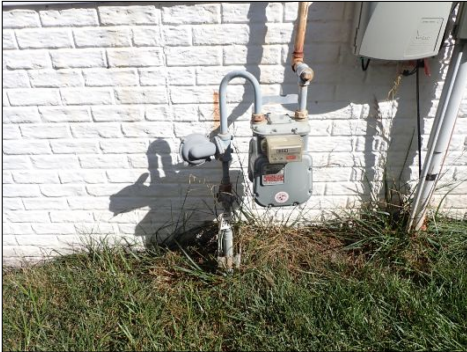
Gas Meter

- Inspected
- The main fuel shut off is at gas meter outside. A wrench is needed to turn this valve. Get to know where the gas shut off valve are for each gas appliance as well.

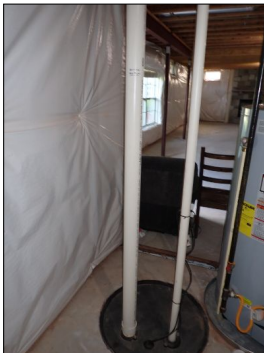
Sump Pump

- Inspected - Check your sump pump regularly (Recommended quarterly)
  - Two Wire Sump Pumps - Testing a two wire sump pump is very easy. The inner most plug that is actually plugged into the wall is the power to the float. The outer plug that is plugged into the float plug is power for the pump itself.
1. Unplug both from the wall and separate them from each other.
  2. Before you proceed, make sure there is water in the sump pit. You can run the pump without water but only for a brief second as it will damage the pump. If there is water in the pit, the pump can run until you hear it become empty.
  3. Take the pump plug and plug it into the wall and listen to the pump actuate. If there is water you can leave it for a few seconds then remove but just knowing the pump functions is what you were testing for.
  4. Return the plugs to the original state.

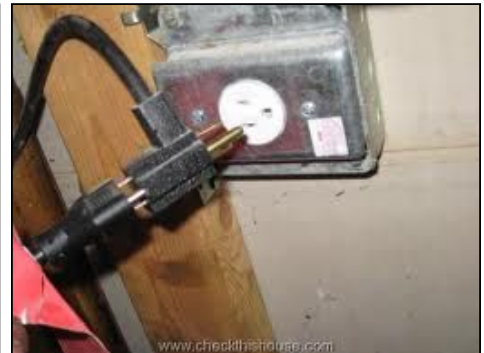
Sump Pump Discharge

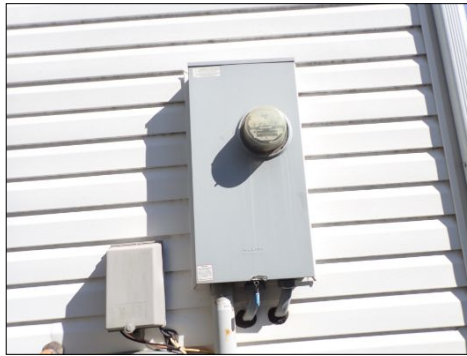
Underground Service to Meter

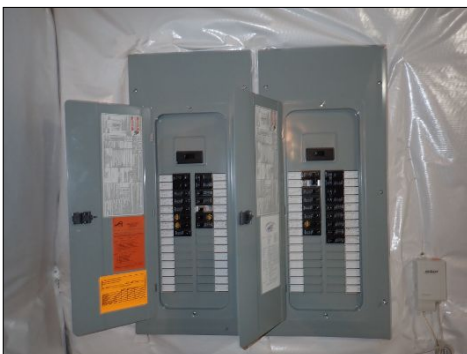
Main Electrical Panels

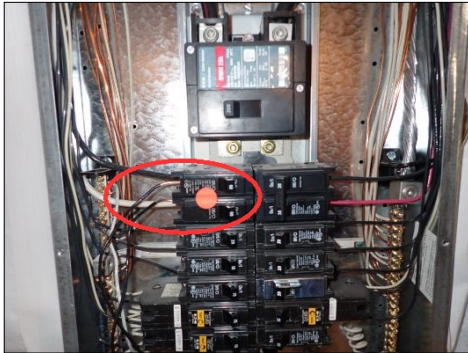
• Inspected - Repair / Replace - The circuit breakers for the HVAC system are 60 Amps. There are two individual 60 amp breakers providing power to the same piece of equipment. These should be replaced with a single double pole circuit breaker by a licensed electrician.

Circuit Breaker

NOTE - While replacing the circuit breakers, electrician should correct the excessive exposed copper conductor on the surge protector.

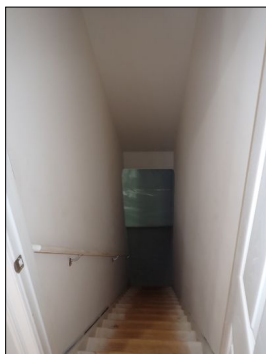
• Inspected - Repair / Replace - The 3 way switches in the stairway to the basement are not wired correctly. When one switch is off, the other should be able to turn the light on and back and forth forever. In this case, when one switch is turned off, the other ceases to function. Have these switches correctly wired by a qualified electrical contractor.

3 Way Switch Wiring

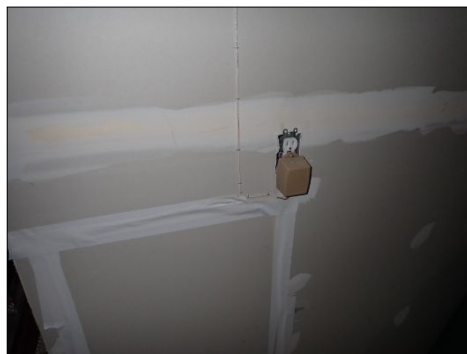
• Inspected - Safety Item - The outlet in the basement to the right of the HVAC system needs a cover. Easy Fix.

Open Electrical - Basement

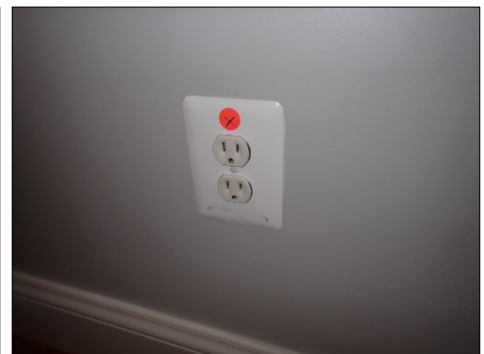
• Inspected - Safety Issue - There are outlets in the home that have the front plastic outlets face that is breaking off of the internal workings of the outlet. I have marked these outlets with an orange sticker with an X on it. These outlets should not be used until corrected. Have these outlets replaced by a qualified electrical contractor.

Cracked Outlet - Dining

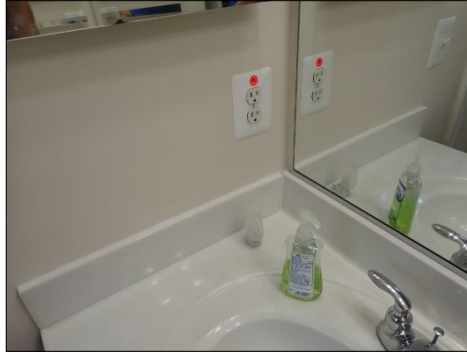
Cracked Outlet - Bathroom

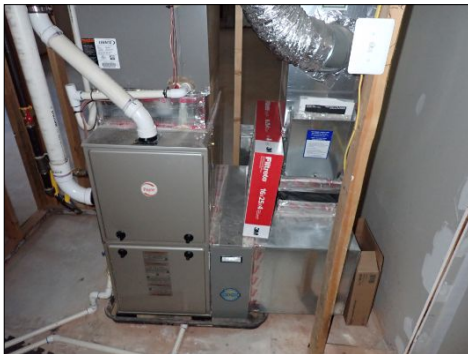
- Unit #1 - This furnace has a manufacturer's specification for heat rise of 35 degrees to 65 degrees. The heat rise (i.e. the difference in temperature of the intake air (76 Degrees) and the delivered air (117 Degrees) was 41 degrees. This is within the above specification. This is an indication that the unit is operating in a normal range.

Gas Furnace - Unit #1

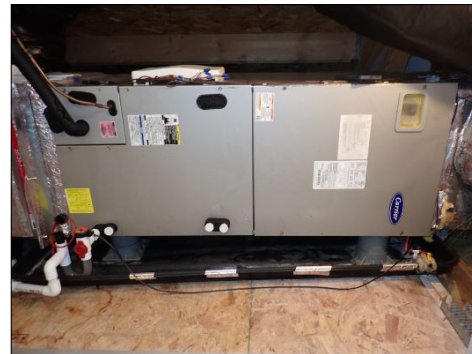
- Unit #2 - The System heat was functioning properly in heat pump mode.

Heat Pump - Air Handler - Unit #2

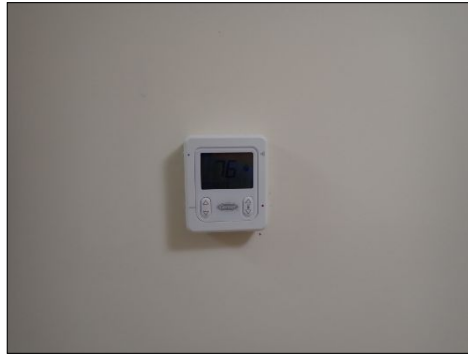
- Inspected - Repair / Replace - The thermostat on the loft level was disabled. You have the ability to have a zoned system for the upper-level HVAC. Have a qualified HVAC contractor correct.

Disabled Thermostat

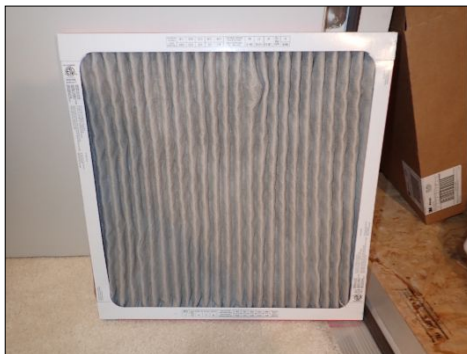
HVAC Filter

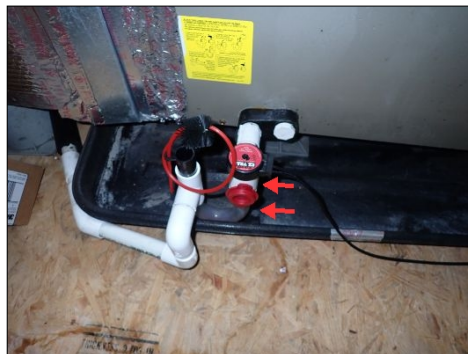
- Inspected
- The Filter was dirty for the upper-level HVAC system, so I replaced it.
- Maintenance Issue - The picture below is a condensation drain. This drain takes water from the HVAC system to a drain. Ensure this is kept clean using a brush and some warm water with bleach 1-2 times a year. Tutorial - <https://www.youtube.com/watch?v=8MPWJ8Q0BdY>
- Maintenance Item - The refrigerant line for the **A/C** unit has old and cracked insulation on it. This pipe should have insulation covering the entire pipe so the unit is more efficient. Add a new piece of insulation to this pipe.
- Maintenance Item - This HVAC unit has a humidifier which had a drip pad appearing to be in need of replacement at the time of the inspection. You should become familiar with humidifier operation, cleaning, and maintenance if you intend on using it. See **DIY** section later in report.

Condensation Drain  
Maintenance

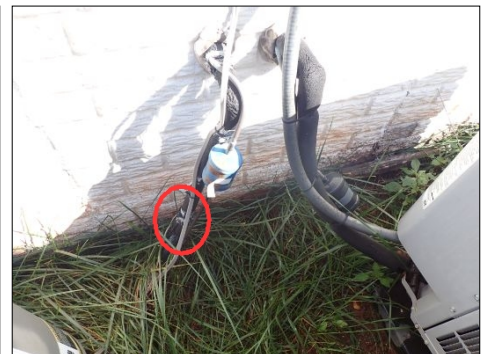
HVAC Refrigerant Lines

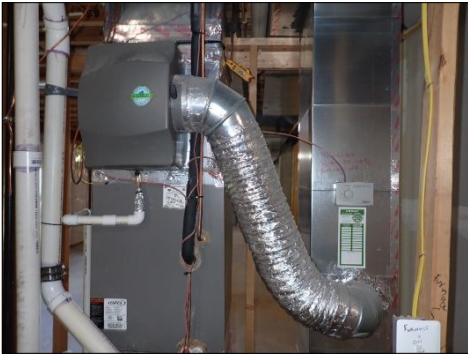
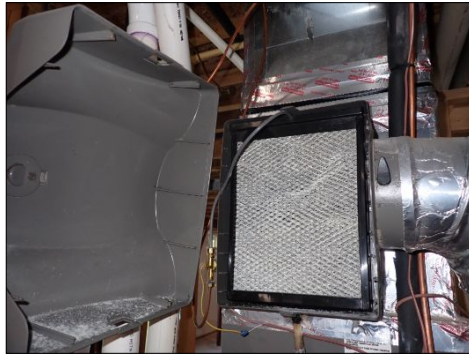
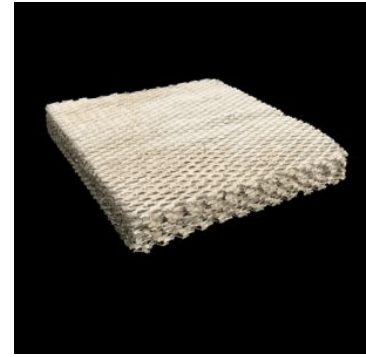
Humidifier System

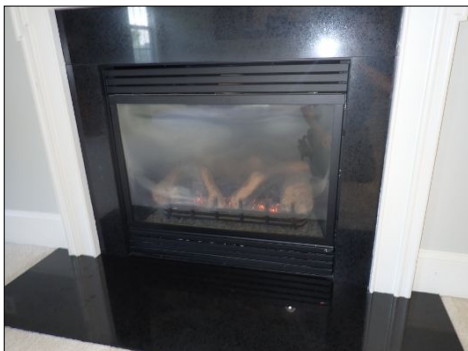
- Inspected - Repair / Replace - The gas fireplaces have glass screens that are dirty / stained. Have the gas fireplaces serviced and cleaned by a licensed contractor.

Gas Fireplace #1

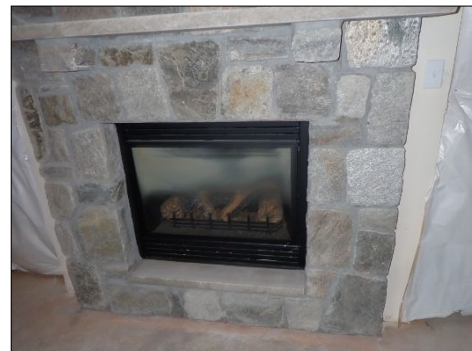
Gas Fireplace #2

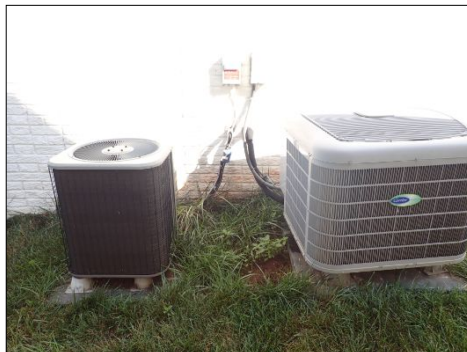
- **Budget for Replacement - One or more of your outdoor Cooling units are older. I recommend you begin to budget for replacement so you are prepared financially when the time comes. Estimated Cost - \$4,000 - \$4,500**
- Inspected - Repair / Replace - The unit does not appear to be operating efficiently.

Compared to the upper level HVAC system, this unit appears to be struggling under the same operating conditions. I recommend you have a licensed HVAC contractor service this unit and make any necessary repairs. Any recommendations made by the technician concerning maintenance and upkeep should be completed with receipts provided for your records.

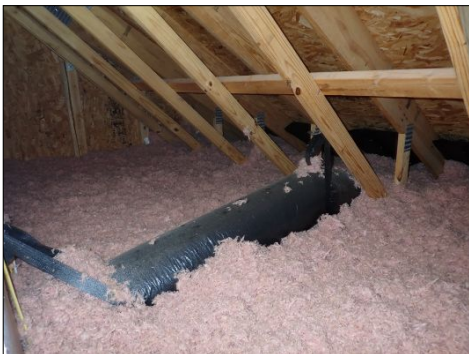
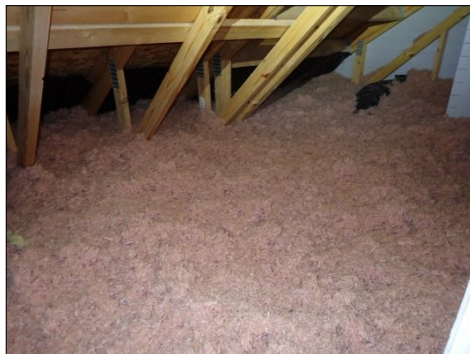
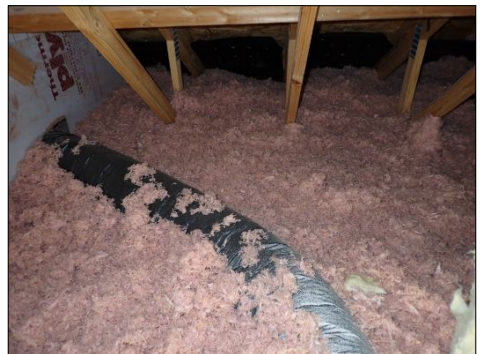
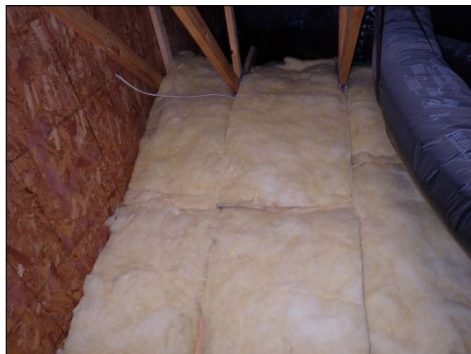
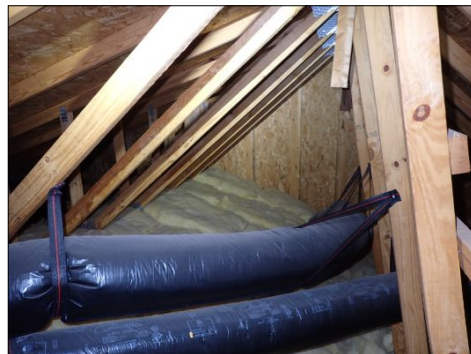
- Inspected - This home has both blown in loose fill Fiberglass insulation and batt fiberglass insulation. Loose fill insulation is on flat areas with batt insulation on sloped / vaulted areas.
- Maintenance Item - Check your attic area 2-3 times a year. Look for any changes in the insulation, signs of pests, water or moisture, etc. Finding issues early will reduce the cost to repair.

Attic Insulation

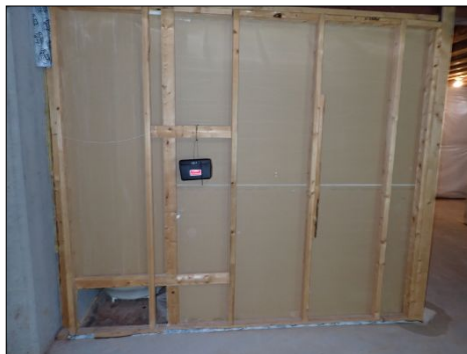
- Test in place - Will be picked up Friday and the results sent directly to you.

Active Radon Test

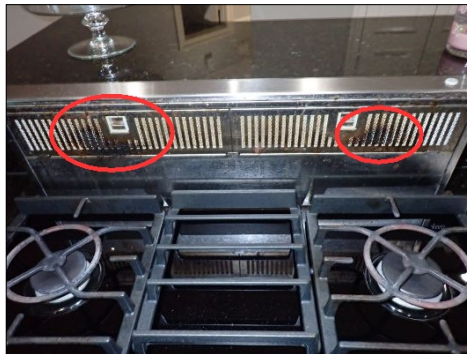
- Inspected - Repair / Replace - The filters for the exhaust fan are greasy and also have burn marks on them. These filters should be replaced if they cannot be properly cleaned.

Exhaust Fan

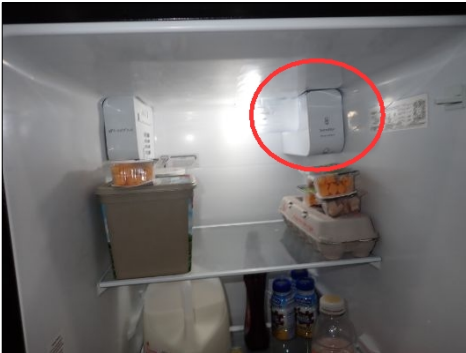
Refrigerator Filter

- **Maintenance Item - My recommendation is to always replace the filter when you initially move in.**
- **Inspected - Repair / Replace - The plastic shelf on the door of the refrigerator is cracked.**

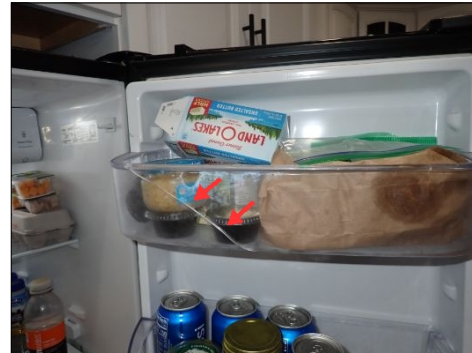
Refrigerator - Door Shelf
